Seismic Shocks in the Myanmar and Thailand Earthquakes: Causes, Impact, and Key Takeaways for Delhi

April 4, 2025

ZONE4SOLUTIONS *#DisasterFreeIndia*

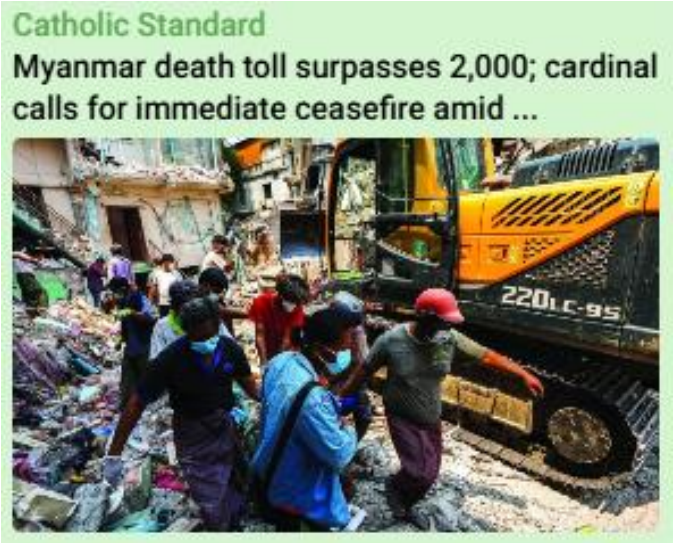
The earthquake leveled entire neighborhoods, collapsed roads, bridges, and religious sites, and left a path of devastation across Mandalay, Myanmar's second-largest city.

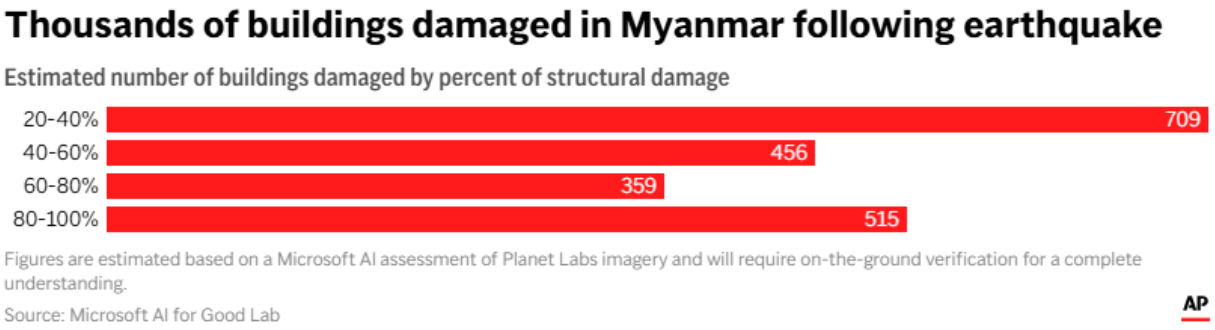
The AI analysis revealed that:

- 515 buildings in Mandalay suffered 80% to 100% destruction
- 1,524 buildings sustained moderate damage (20% to 80%)

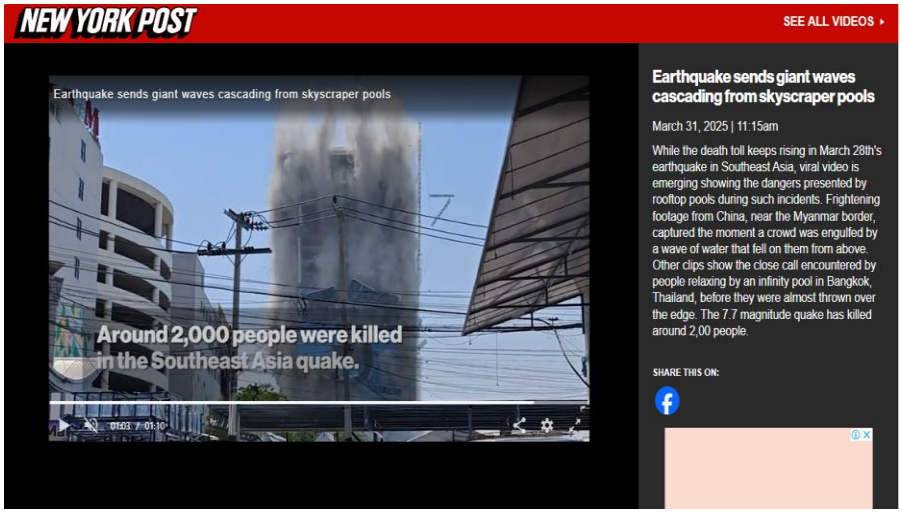
As the death toll climbs past 2,000 from the March 28 earthquake in Southeast Asia, shocking videos have surfaced showing the unexpected dangers of rooftop pools during seismic events. Viral

footage from China, near the Myanmar border, captures the terrifying moment when a massive wave from a rooftop pool engulfed a crowd below, sending people scrambling for safety. In Bangkok, Thailand, another clip shows people relaxing by an infinity pool just before the tremors caused water to surge violently, nearly throwing them over the edge.

While the 7.7-magnitude earthquake has caused widespread devastation, these videos highlight another lesser-known hazard—the displacement of water from rooftop pools in high-rise buildings. The force of the quake turned these serene spaces into sudden tidal waves, adding to the chaos. As rescue efforts continue across Myanmar, Thailand, and neighboring countries, the footage serves as a stark reminder of the unexpected dangers posed by earthquakes—even far from the epicenter.

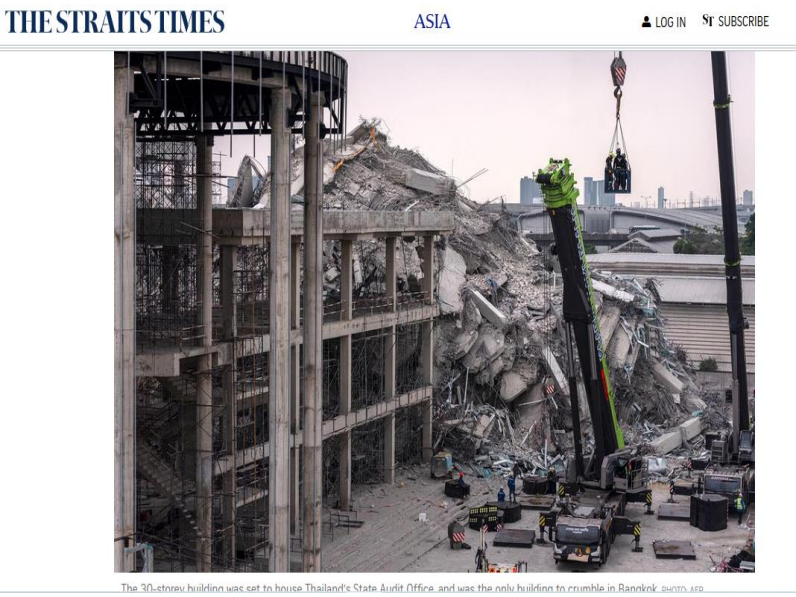
Bangkok, April 1, 2025 – Investigators have confirmed that the collapsed 30-story tower in Bangkok, which crumbled during the March 28 earthquake, was built using substandard steel produced by a factory that had been shut down by authorities months earlier.

Tests conducted by the Iron and Steel Institute of Thailand revealed that steel bars used in the construction failed key quality assessments, including mass, chemical composition, and stress resistance. The subpar metal was traced back to Xin Ke Yuan Steel, a company whose Rayong-based factory was shuttered in December due to safety

violations. Thai authorities had previously seized over 2,400 tonnes of steel from the facility. The 30-story building, meant to house Thailand's State Audit Office, was the only structure in Bangkok to collapse following the 7.7-magnitude earthquake that struck Myanmar. The disaster claimed at least 12 lives and trapped nearly 80 workers.
